ALIGNING THE 4TH MAIN BEARING

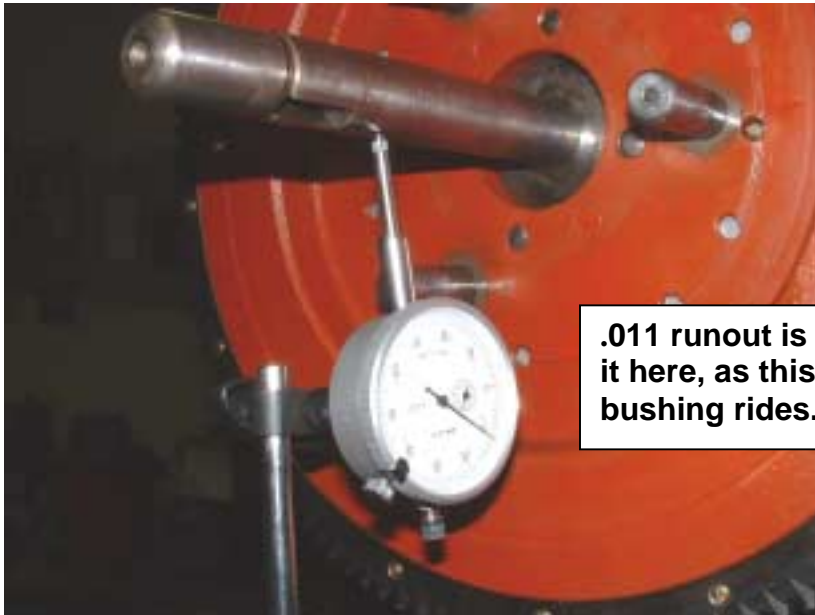
.011 runout is not unheard of. Check it here, as this is a surface where a bushing rides.

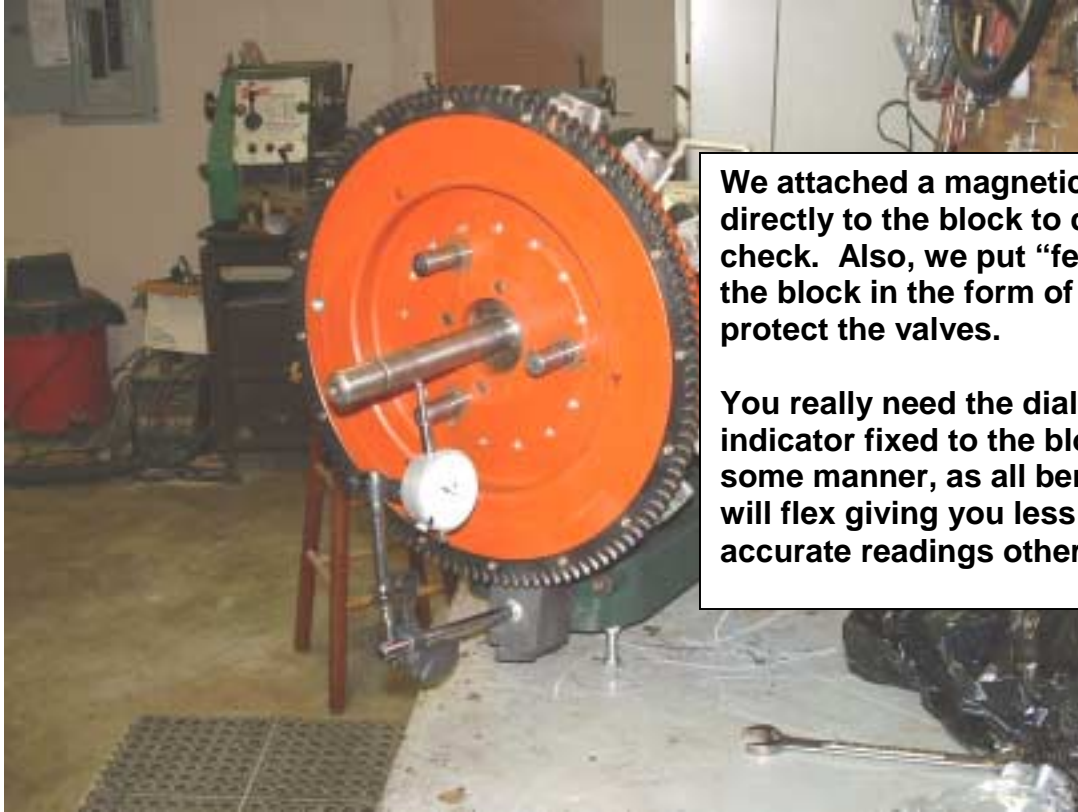
When doing this, you need to keep track of the relationship of the flywheel to the crankshaft and the transmission shaft to the flywheel. We were able to find a point where the total runout was .002, which means it was within .001 of being perfectly concentric with the crankshaft. This is within the added up clearances and should be acceptable and produce an engine that runs smoothly.

We attached a magnetic base directly to the block to do this check. Also, we put “feet” on the block in the form of bolts to protect the valves.

You really need the dial indicator fixed to the block in some manner, as all benches will flex giving you less than accurate readings otherwise.
