After the initial focusing of a Model T headlamp, is the pattern of the oval vertical rather than horizontal?  
Here's how to fix it.

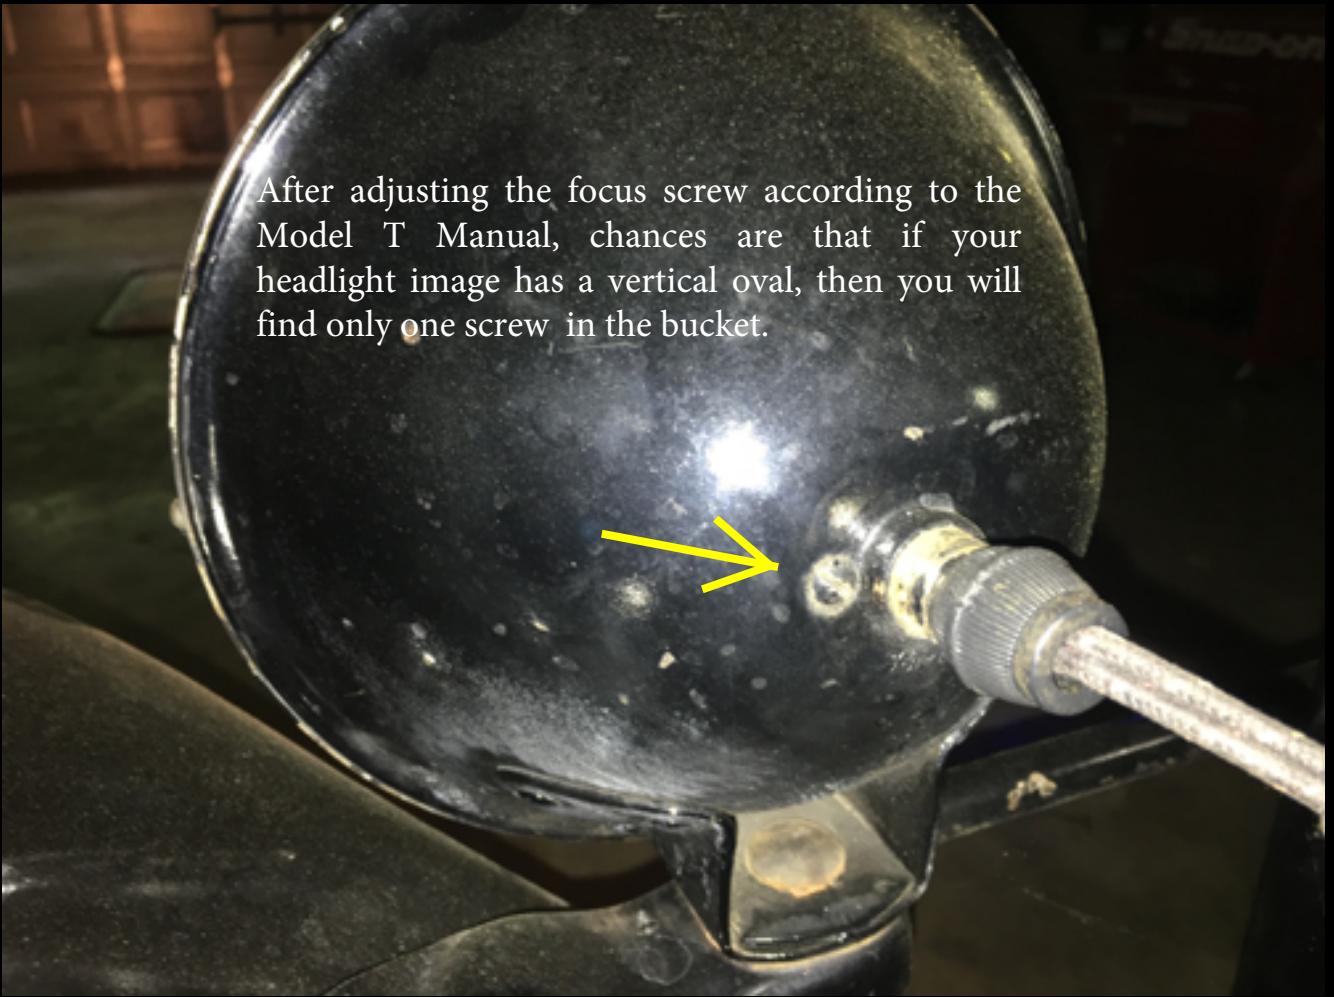
This image shows the focused oval situated vertically. This is not a good situation because it does not light up the road. Why did this situation occur? Because the vintage bulbs fit the lamp socket in such a way that the lit area aligned horizontally. Today's bulbs align the lit area vertically. The elements are made differently.

After adjusting the focus screw according to the Model T Manual, chances are that if your headlight image has a vertical oval, then you will find only one screw in the bucket.

The fix is simple. Rotate the socket 90 degrees.

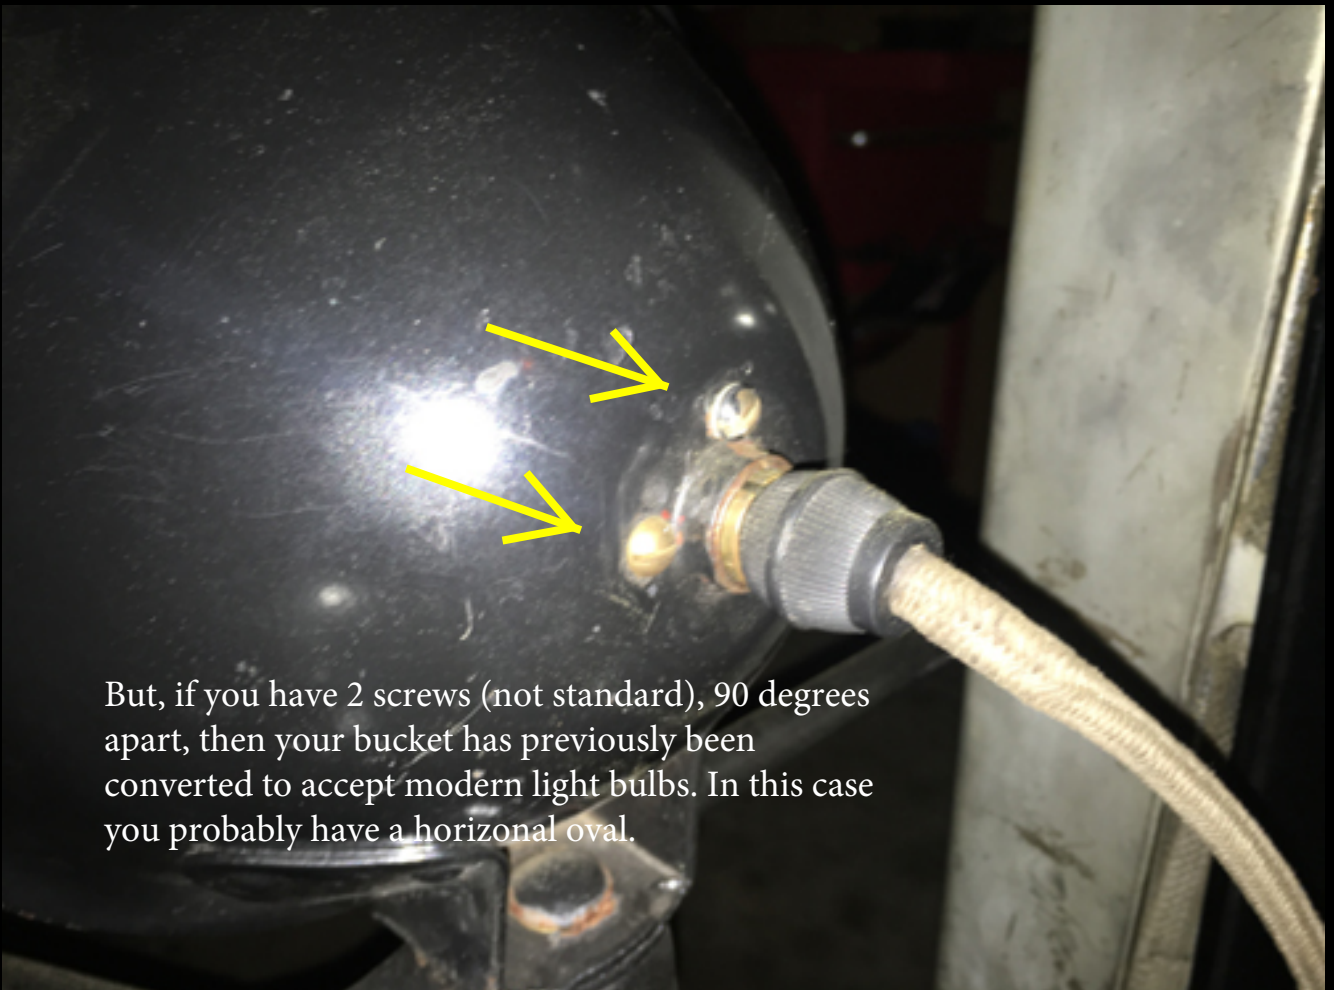
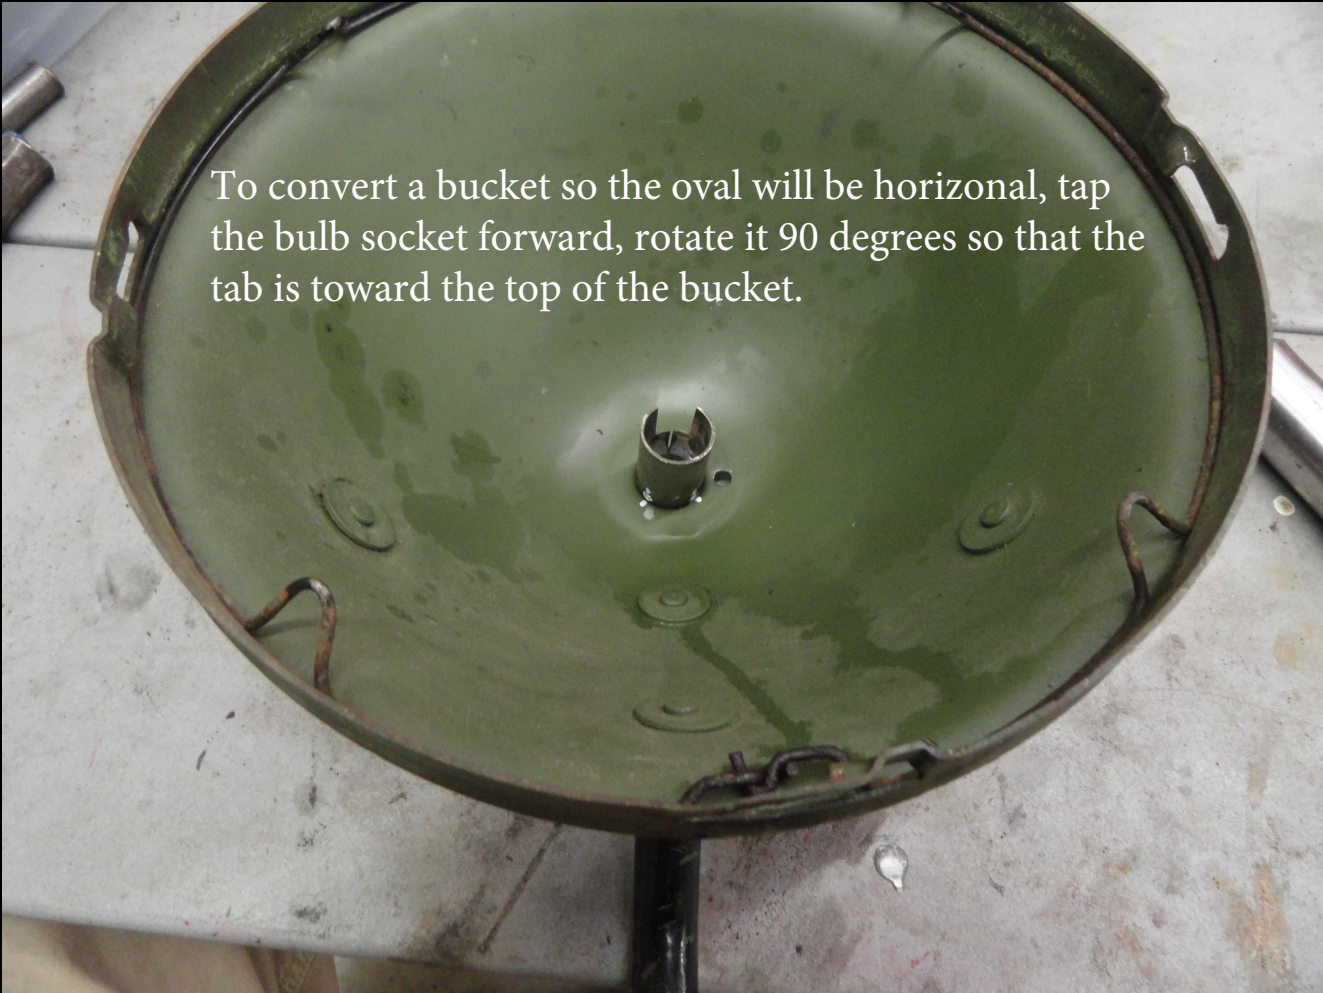
But, if you have 2 screws (not standard), 90 degrees apart, then your bucket has previously been converted to accept modern light bulbs. In this case you probably have a horizontal oval.

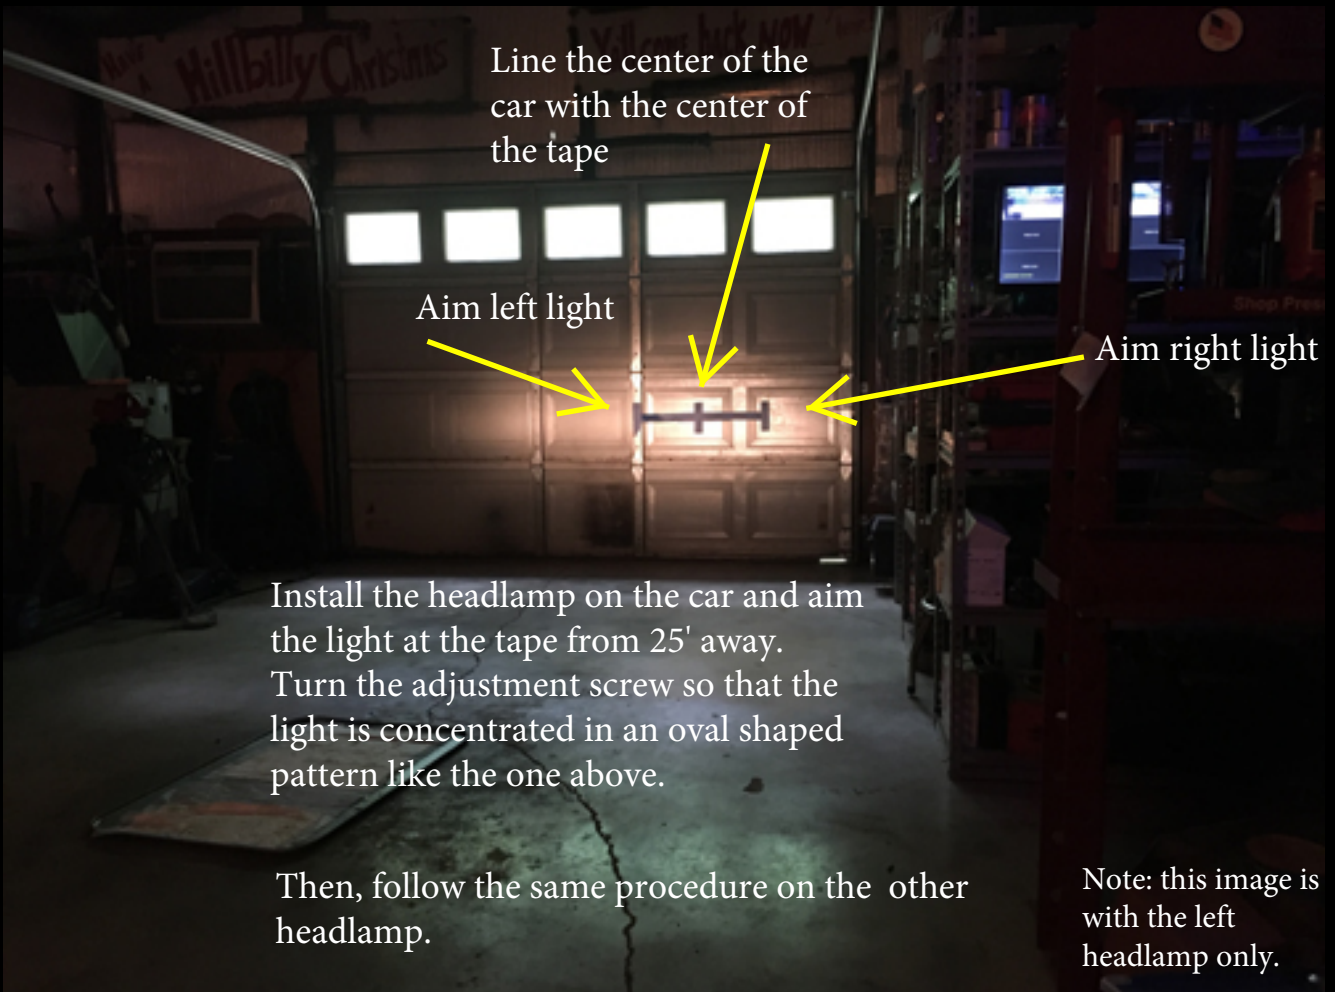
Note: this image is with the left headlamp only.

Drill a hole in the bucket that will align with the threaded tab on the socket. Install the screw and the spring, from the outside, threaded into the tab. Install the cotter pin in the screw. Turn the screw to see if the socket moves in & out as designed. The empty hole can be filled with a short screw held in place with your favorite epoxy.

Install the headlamp on the car and aim the light at the tape from 25' away. Turn the adjustment screw so that the light is concentrated in an oval shaped pattern like the one above.
