IT'S NEVER AS EASY AS YOU THINK IT'S GOING TO BE

by Dennis Plank

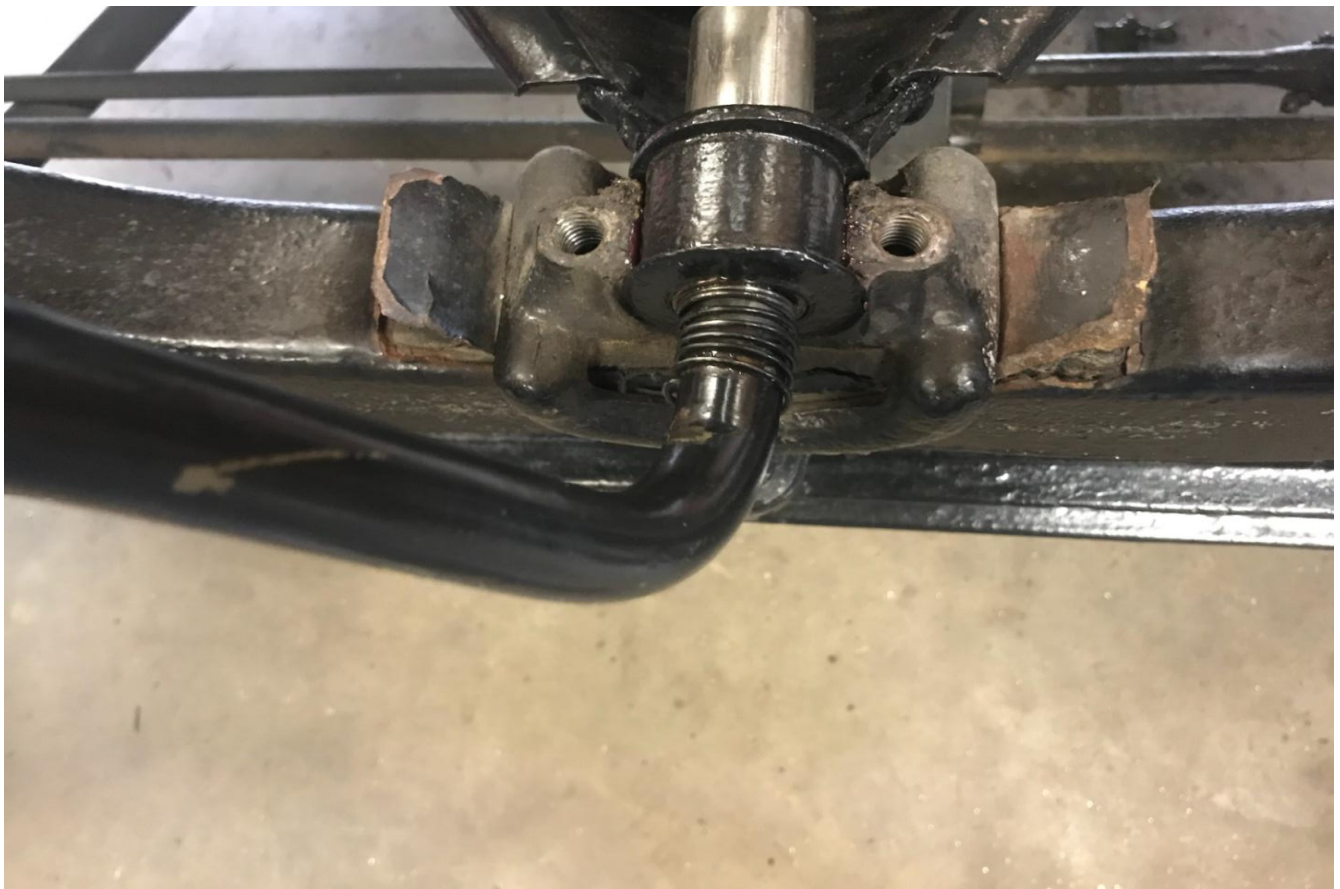
I got it done and decided it was time to make the swap. I was able to get the old engine out with no problems and was sliding the new engine back on the frame rails when I noticed something that didn't look right on the front cross member. It almost looked like a shim under the front motor mount. On further inspection, I could see that the cross member had rotted completely out to the point that the spring was coming up through a nice rectangular hole in the cross member.

Not good news when you are anxious to hear your new motor. Time to replace the cross member. Ricky showed up and said he had one hanging on the wall in his barn he would give me, so I took him up on the offer. It's a job drilling all those rivets out, but I finally got it done. No, he didn't stay and help.

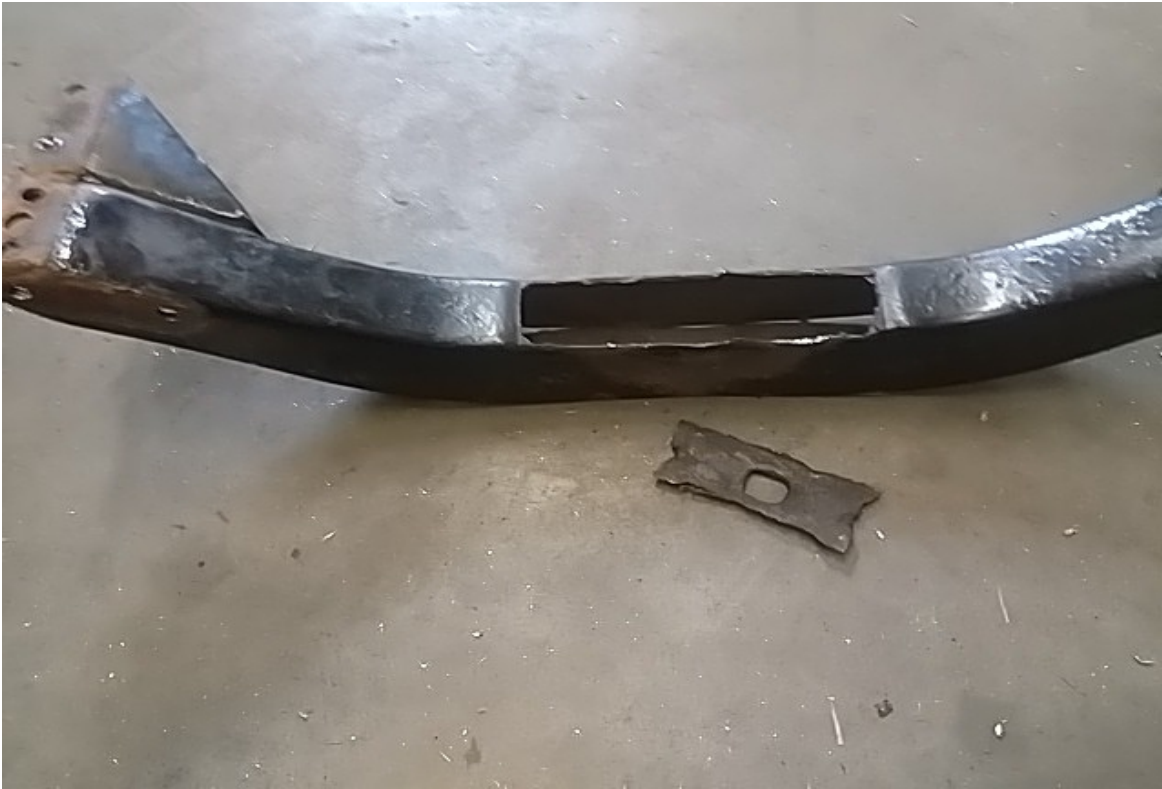
Here is another shot of the damage. The hole was so clean it almost looked machined.

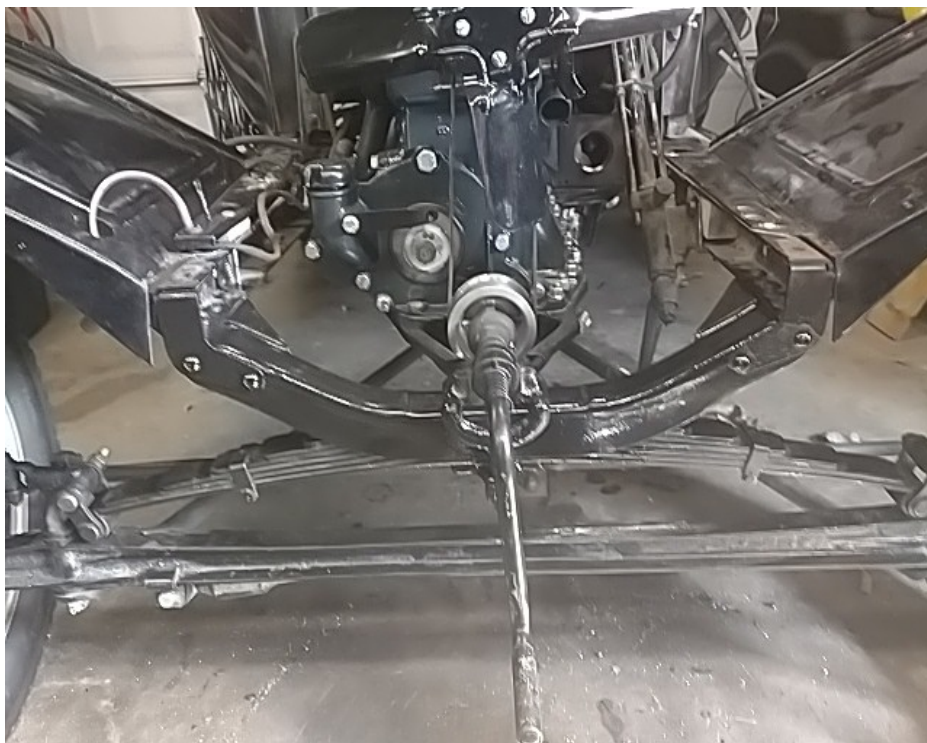
Here is the completed project with the new cross member and engine in place.
