# DEATH WOBBLE

by Phillip Lee

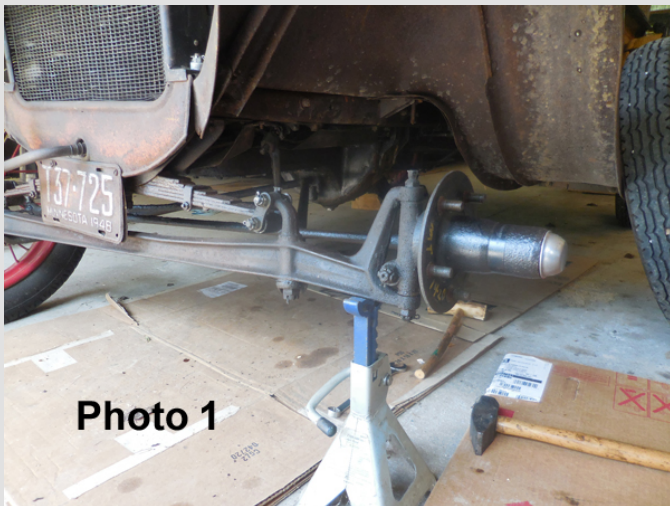
Photo 1

Now that the part is in I can get started. First thing is to jack up the front and put the jack stand under the axle (Photo 1). Then I remembered to chock the back wheel (Photo 2). Don't wanna get run over. Got the impact wrench and removed the left front wheel to give me a little more room. I then took the castle nut off (it did not have a cotter pin), whacked the pitman arm a couple of times with my wood mallet and to my surprise the pitman arm fell off. It was a good start. I noticed that before the steering bracket can be removed, the commutator rod connector has a pin that will have to be knocked out with a little grinding. Not lots of room under there so to get that job done I drilled it out (Photo 3). The nut and bolt that runs perpendicular to the frame came out easy, but the two that are vertical started spinning once they were a little loose. Time to put the thinking cap on. After a cup of coffee, I took a large flat screwdriver and forced it between the bracket and frame to put pressure on the nut and that worked (Photo 4).

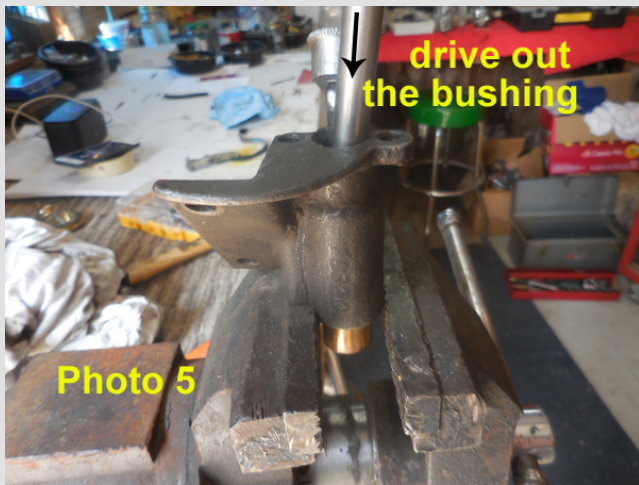
Once the bracket was off and cleaned up, I put the bracket in a vice and used a 1/2" rod about 8" long to drive out the bushing (Photo 5). Using the vice and a wood block, the bushing was pretty easy to press in the bracket (Photo 6). Bill had shown me a method to enlarge the bushing if needed. Mine did not need to be reamed out. Nor did the outside of the bushing need to be dressed down. I put lots of wheel bearing grease in the bushing and on the steering shaft (Photo 7). The bracket went back into place easily. The perpendicular bolt tightened good, but the vertical was spinning again. Got the trusty screwdriver out and put pressure on the bracket and got the bolts tightened. I found a nail the right size to use as a pin in the commutator rod arm, but the head contacted the steering shaft so I used a dremel tool with a small grinding wheel to grind down the nail head just enough to clear the steering shaft (Photo 8). I got the pitman arm back on and installed a cotter pin (Photo 9). Last was getting the front wheel back on, removing the jack stand and chocks. I took Tinker T for a spin and surenuf the T handled much better.
