Model T Rear Rebuild by Brett Ritter

Due to the damage on my axle from a wheel run loose years ago and some old school patchwork of dimpling the taper, my 27T needed to have one replaced.

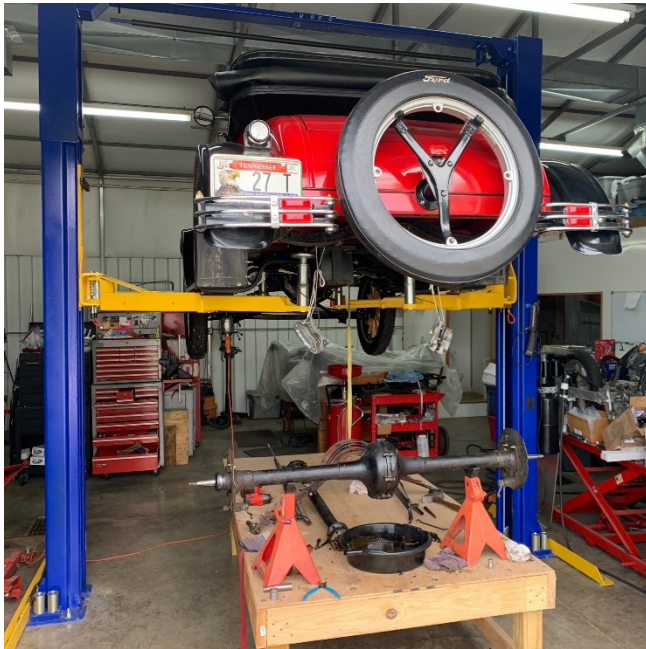
As we opened the rear end and torque tube, we were confused when we saw large chunks of soft metal in the oil we drained. Later we learned that these were parts of the babbitt bushings that the axle gears ride on. When we looked further, we saw damage from the babbitt spacer bushings crumbling and working their way through the entire rear. we decided to do a complete overhaul and rebuild the spring.

Not being able to stop myself, I decided to convert everything to modern bearings, bushings and seals. After disassembly, I took the reared pieces to be cooked at the transmission shop and ordered in the needed parts.

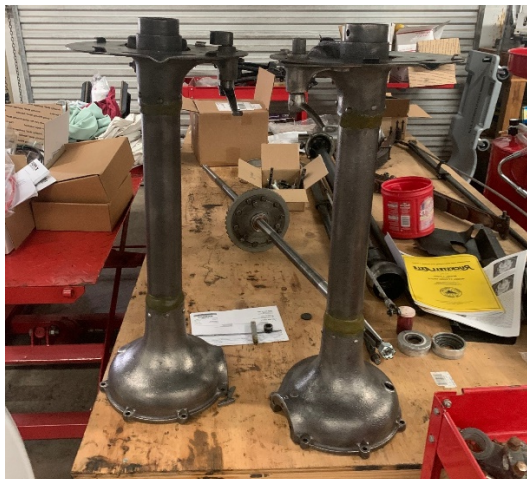
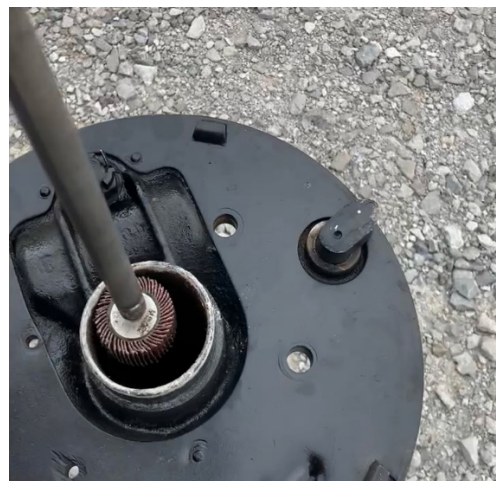
Once I got the parts in and the rear end housing returned, I realized that the built-up grease and oil in the tubes of the rear were still there, so we made a tool of a flapper on a ½ inch dowel to clean the inside of them. It worked well and was a fast solution. Then we painted all of the housing pieces and torque tube with a first coat of paint.

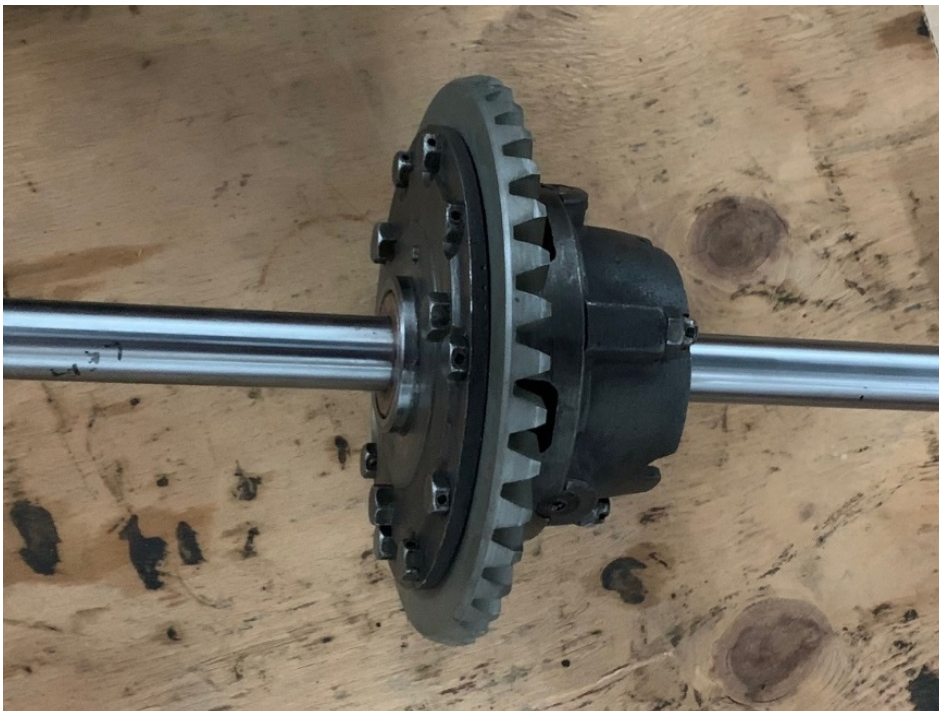
We pressed the new axle gears on the new 1/16th" longer axles with our hydraulic press. (We did not have luck using the method shown in the video with the babbitt plate.)

We set the spider gears back in place and fastened the new ring gear to the carrier assembly. And then put the axles in the housing and put the assembly together. The assembly was a bit tight when we test fitted without the rear end housing gasket as recommended, so we sanded the bronze spacer between the axles down a bit until we got the desired fit.

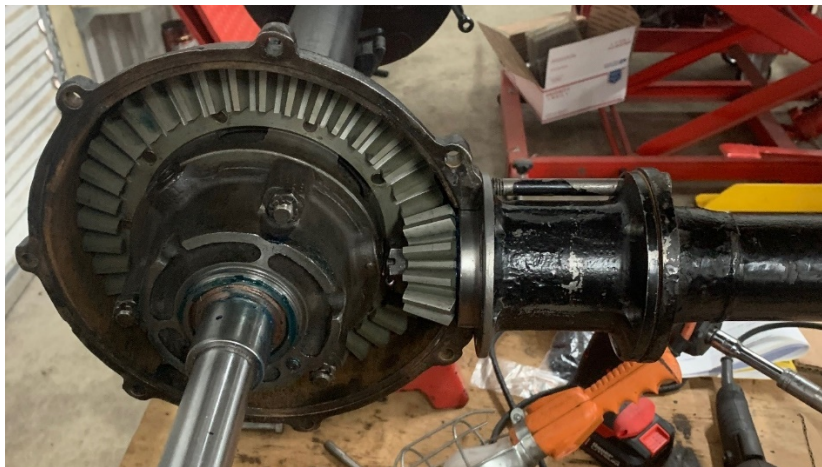
Now it was time to attach the torque tube to the rear end. Interestingly, each time we would join the torque tube to the rear end, they would both lock up. Then we would separate them and both would turn freely. Finally, after calls to Dave at Chaffins we came across the issue. The allen bolt that holds upper bearing stop that comes with the torque tube bearing kit was locking against the housing when the gears pushed together. We made our own replacement on the lathe and used regular set screws and the issue cleared up immediately. Dave said that different year housings have different inner diameters and ours was one of the tighter ones.

To set the Pinion Gear depth we removed the right side of the rear end housing so we could measure the gear mesh side to side and depth. The side to side lash was loose, and the pinion gear depth was shallow. Since we didn't have any thinner shimming/gaskets to use to join the rear to the torque tube, we removed the pinion gear and lathed a few thousandths off of the torque tube bearing carrier so it set the pinion gear deeper. This also took up the lash to bring us right into spec.

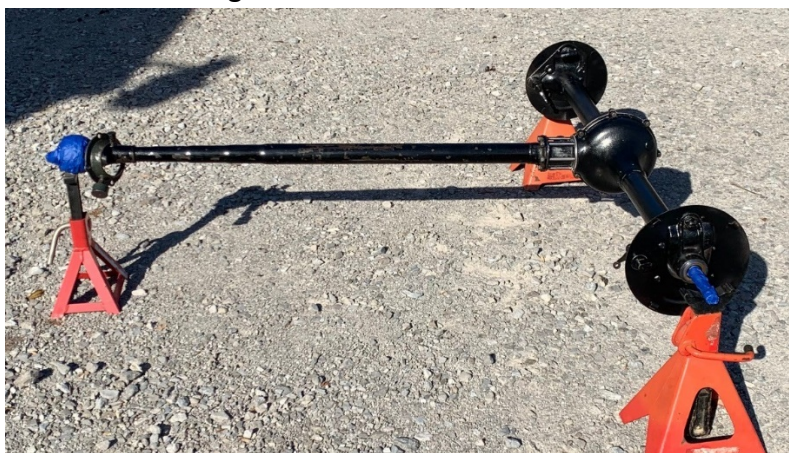
We did final assembly, safety wired, torqued and painted the entire unit as one piece and hung it back in place with our refreshed rear spring.

Then I learned the lesson that I should have installed the radius rods before attaching the torque tube to the rear end housing, having to pop them apart leaving the 6 spool bolts threaded in a few threads and then reassembling.

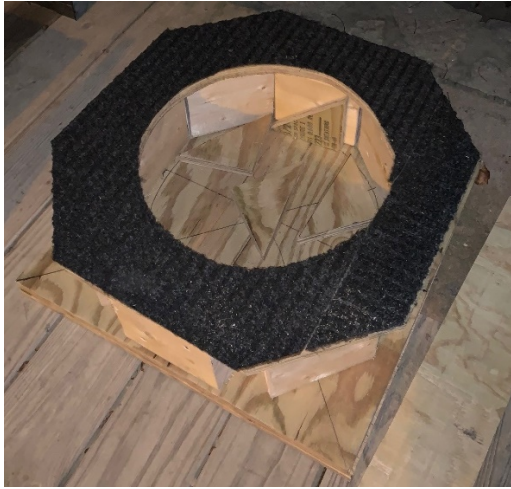
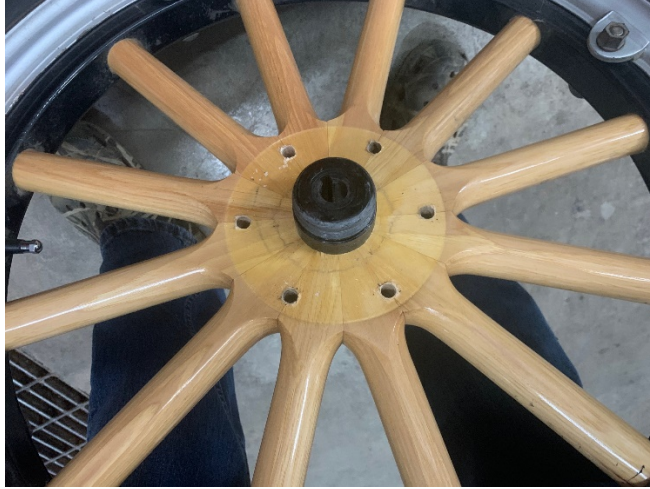
Of course, as we were putting all of the finishing touches I realized that I was about to install a damaged hub on the new axle. So, I ordered in a new hub from Lang's, watched a video on how to make a wood wheel spoke press and installed a new hub. I was amazed how well the press worked. It was astonishing!
