What is a "burnt valve"?

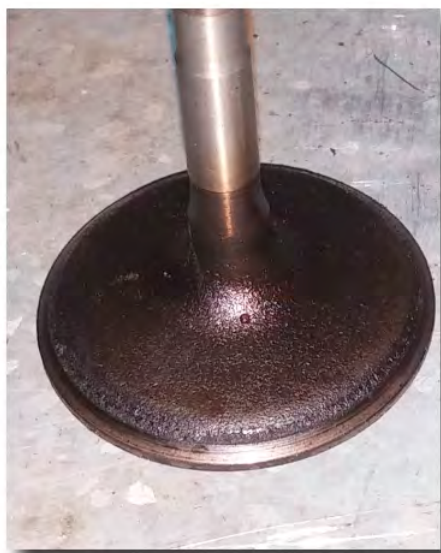
This valve is making seating properly

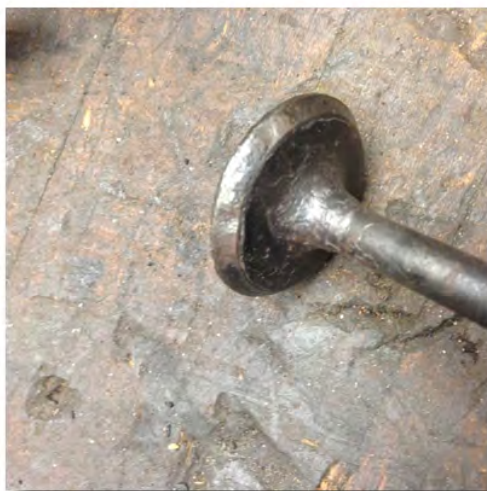
This valve is burnt and leaking

What is a burnt valve? The most common definition that I was able to find on the web regarding a burnt valve states: A burnt valve can happen for one of many reasons, but the underlying issue is, the valve is not seating correctly and allows hot engine gases during the combustion phase to leak past the seal which is formed by the valve and seat. When the seal is lost, the hot exhaust gases escape past the valve (can happen to either the intake or the exhaust valve, but is much more common on the exhaust) and wreak havoc. The burnt valve is usually not the cause of the issue, but more so the outcome of a different issue.

Common causes: As leaded fuel's burned, it leaves a deposit on the combustion chamber areas, most notably the valve seats on both valves and heads, and valve stems. These deposits prevent the valve from seating, thus the exhaust gas leaks past and eventually burns the valve and seat. Also, unleaded gas leaves gummy deposits on the stem, thus slowing down valve action.

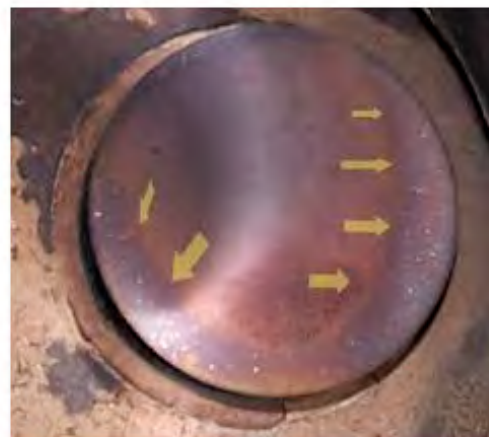
This is obviously burnt and showing hotspots

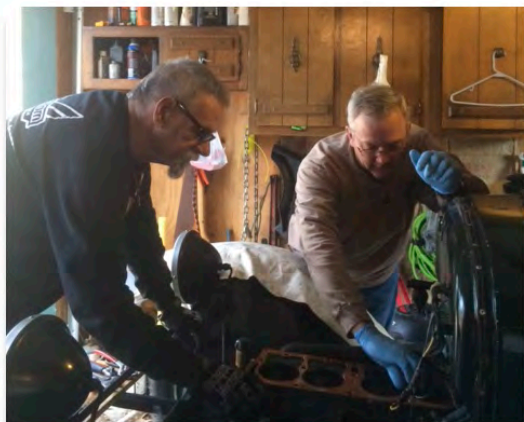
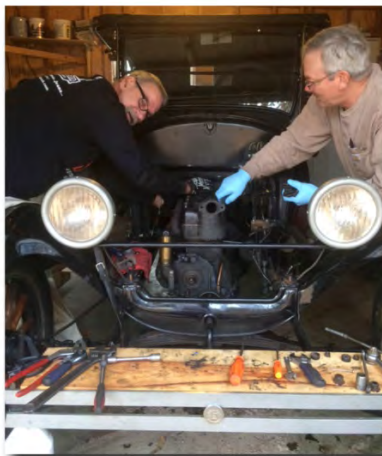
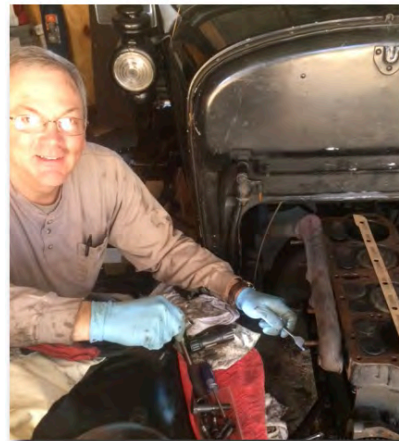
In the following photos, Ralph Williams and Gary Elam are replacing burnt valve on Gary's 26 T.
