Magneto University
Or
Getting the Spark Back in Your Relationship (with your T)
By: Steve Shelton - Mulberry

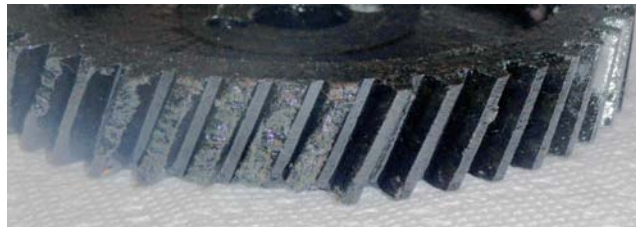
Last year our editor Bill Robinson called saying one of his several T's had quit running on a tour. In the course of investigating the cause he first found a stripped fiber timing gear (shown on the right). Further investigation revealed considerable slop in the crank – forward

and rear movement was considerably more than it should have been. This led to finding that the third main bearing cap's thrust surface was worn and explained why it had long ago quit running on magneto. Having read Emerson's little quote somewhere along the line Bill decided to fix it right. Between the two of us we queried experts John Regan and Ron Patterson about how to proceed. The advice was that fixing the third main was do-able provided the new cap was made specifically to fit...not a generic cap. Other wise we ran the risk of flexing (bending) the crank with too much or too little bearing pressure on it. Bill carefully measured the journal and ordered a cap poured and bored to fit it. Problem one solved. Next we replaced the timing gear. Both of these jobs are easy if you have the engine out and torn down on the stand.

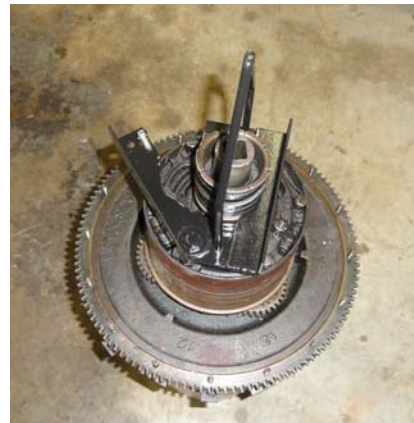
The bigger challenge awaited with the magneto. Bill came up with a tool of his own invention (see picture at right) to lift the transmission off and pulled it. After that he and John Zibell removed the coil ring and from the back of the engine block and then removed all the magnets from the transmission. Bill shipped the magnets to Ron Patterson who recharged them and shipped them back in a specially made crate. The coil ring went to "Total Re-coil" where it was, well, "totally re-coiled." Reports indicated that the magnets had been very weak and that the coil ring was just plain shot. It had a lot of insulation gone and the copper ribbon connecting the windings was broken in a place or two. While these key components were off being repaired Bill ordered parts for reassembly. These included new brass screws to mount the magnets, and the spacers that the magnets rest on as well as shims for the coil ring. We found the magnet holders to be ok, and having heard bad things about the reproductions opted to re-use them.

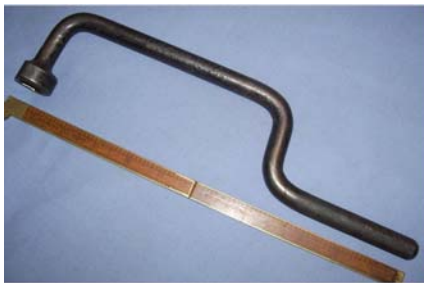
We lowered the tranny down and bolted it on using a special wrench Keith brought with him.

Then we measured with the feeler gages and found we were way off. Something like .060. So, unbolt (using the special wrench Keith brought – left), pull the tranny back off, unbolt the coil ring, add/remove shims, reassemble, remount transmission, measure, repeat as needed. In our case this was 7 times. The challenge is that the coil ring is mounted with four bolts that all sit above the center of the ring. So adding a shim to one corner to close the gap you measured on that side closes that gap but at the same time opens the gap on the other side. The mounting
