Broken Bolt

by John "Big John" Ohlrogge (edited by Bonnie)

Several years ago, is when I first built my 1920 Depot Hack.

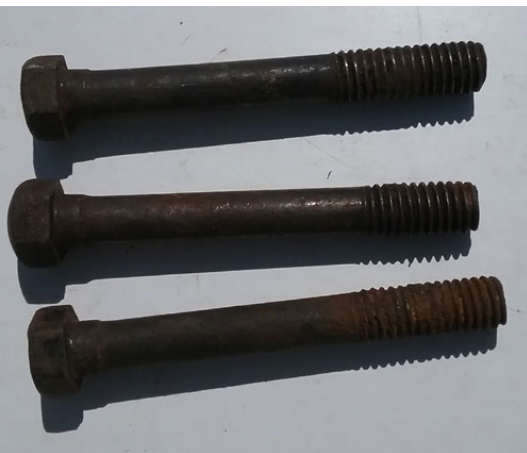
Coated with a good lathering of Anti-Seize Lubricant

To my surprise I managed to get the head off. I was able to unscrew it with my fingers. Then I began to look for possible causes. I noticed that just below the head, on the bolt, there is a shoulder. On the shoulder was quite a bit of rust. So I brushed the bolts with a wire wheel on the bench grinder. Then I decided to coat them with Anti - Seize compound. This eliminated the problem then and for the future.
